## SEAT RING VALVES FAILURE: THE CAUSES AND IMPACTS ON THE CARGO OIL PUMP PERFORMANCE ON MT. KIRANA NAWA

Cargo discharging is one of the important activities in ship operations. MT. Kirana Nawa experienced a delay during cargo discharging in Batangas, Philippines, on 5 October 2023. Normally, the discharging process would only take one day, but at that time, it took two days to complete. This delay was caused by damaged seat ring valves. This study aimed to identify the factors causing the seat ring valve failure, their impact on the performance of the cargo oil pump, and the role of the ship's crew in maintaining the seat ring valve to ensure that the cargo oil pump can operate optimally during the discharging process. The research used a qualitative method, in which triangulation techniques were used to obtain the data. The collected data were then analyzed using the Fishbone diagram. The study revealed the main factor causing seat ring valve failure on MT. Kirana Nawa was the over-running hours of the seat ring valves due to the lack of usage records. It then impacted the cargo oil pump performance, which became not optimal, leaving residual cargo in the ship's tank and causing

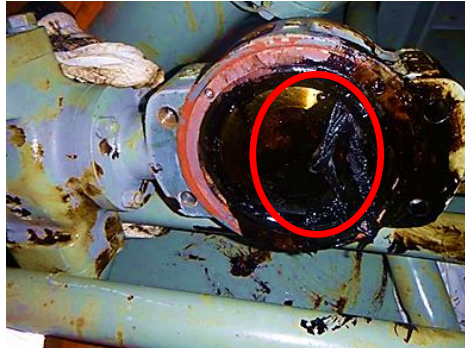
Figure 2. The presence of cotton wool on the valve

One of the factors that cause damage to the valve seat ring is the presence of cotton wool or rags in the valve system. This incident occurred when the Pumpman repaired the valve seat ring on valve S8 in the stripping suction pipe section on 30 November 2023. When the valve was disassembled for cleaning, there was cotton wool or rags in the valve system, which prevented the valve from being fully closed because cotton wool blocked the valve disk. This led to the damage to the seat ring valve.

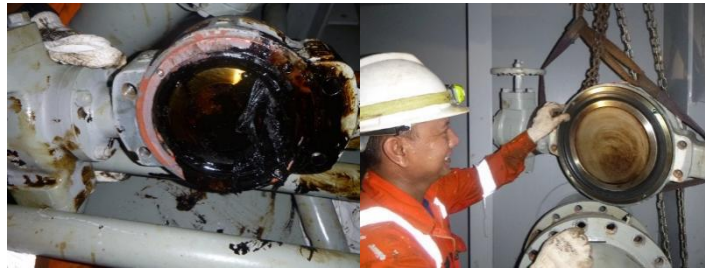
Figure 3. Valve maintenance

Plan Maintenance Schedule (PMS) is a schedule the company has made and planned to carry out equipment maintenance on board. Therefore, the PMS contains equipment that needs maintenance and when to carry out maintenance. However, when conducting research, researchers noticed a problem, namely the busy loading and unloading schedule of the ship, which resulted in the crew being unable to perform maintenance. An example of PMS on board MT. Kirana Nawa, regarding valve checking and maintenance is checking valves carried out every week before loading and unloading activities. However, the valve maintenance is carried out every month. Therefore, the Chief Officer should be able to utilize the time available to maintain equipment on board effectively so that it takes little time and gets good results.

One of the roles of the crew in keeping the seat ring valve in good condition is to conduct a Plan Maintenance Schedule (PMS). This is important because it can improve the performance of the cargo oil pump due to the good condition of the seat ring valve. The results of interviews with the Master further strengthen the evidence that implementing the Plan Maintenance Schedule (PMS) can keep the seat ring valve in good condition.
