## **COAL LOADING STRATEGY IN NON-CRANE BULK CARRIER AS AN EFFORT TO REDUCE BROKEN SPACE IN THE HOLD OF MV AMANAH MOROWALI AMC**

**Farid Wahyu Dyatmika, Wahyu Wibowo, Ria Hermina Sari**

Nautical Study Program and Merchant Marine Polytechnic of Semarang  
\*Corresponding author: rudofficial279@gmail.com

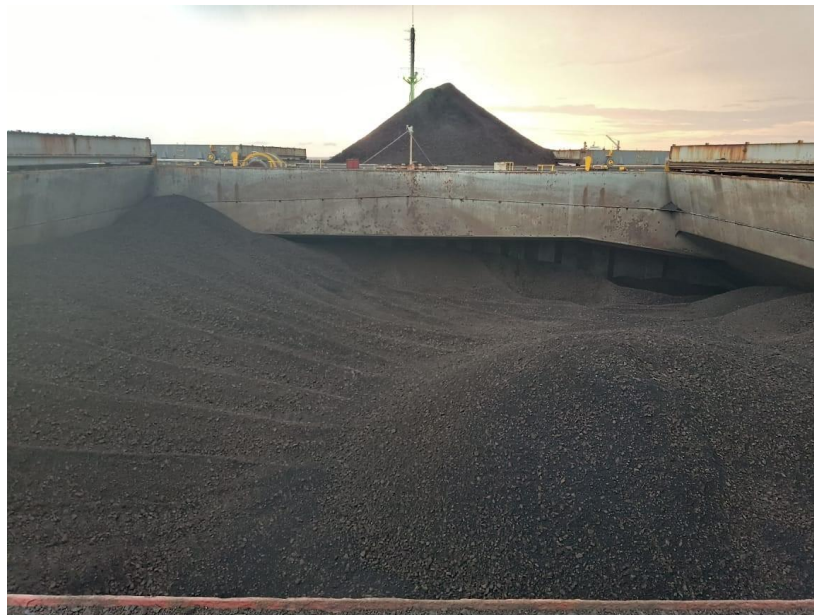
Figure 1. Profile of Hatch No. 2 from the Main Deck  
Source: Researcher Document (2023)

3. Hatch Space Characteristics: The hatch space of MV Amanah Morowali AMC has a unique design that makes it difficult to distribute cargo evenly. Although it can accommodate up to 93,795 MT, the characteristic narrow hatch space at the top causes constraints during the loading process.

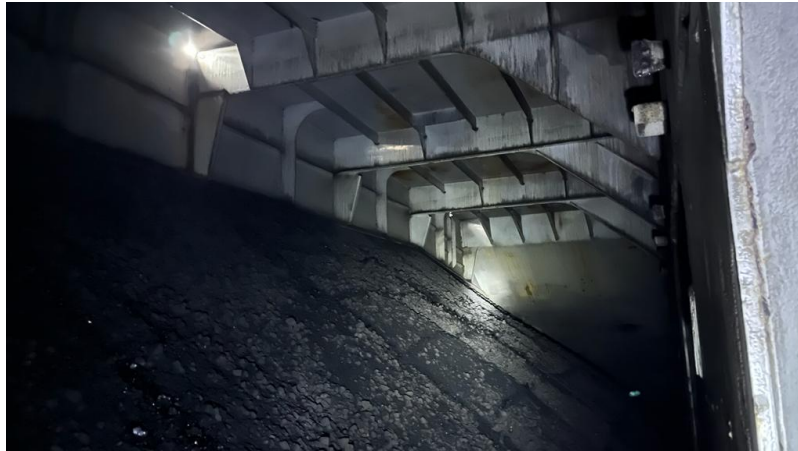
Figure 2. Broken Space in Hatch No 2  
Source: Researcher Document (2023)

1. Delay in Loading Process: The loading process was delayed by 6 days, which should have taken 4 days. This was caused by the foreman's decision not to perform trimming in order to meet the loading target, which resulted in the actual loading reaching 88,000 MT of the planned 91,200 MT. As a result, there was broken space in the hold which resulted in uneven coal distribution.
